Rosemerryn Subdivision, Lincoln

Stage 25 Geotechnical
Investigation Report

**Fulton Hogan Land
Development Limited**

Reference: 520194

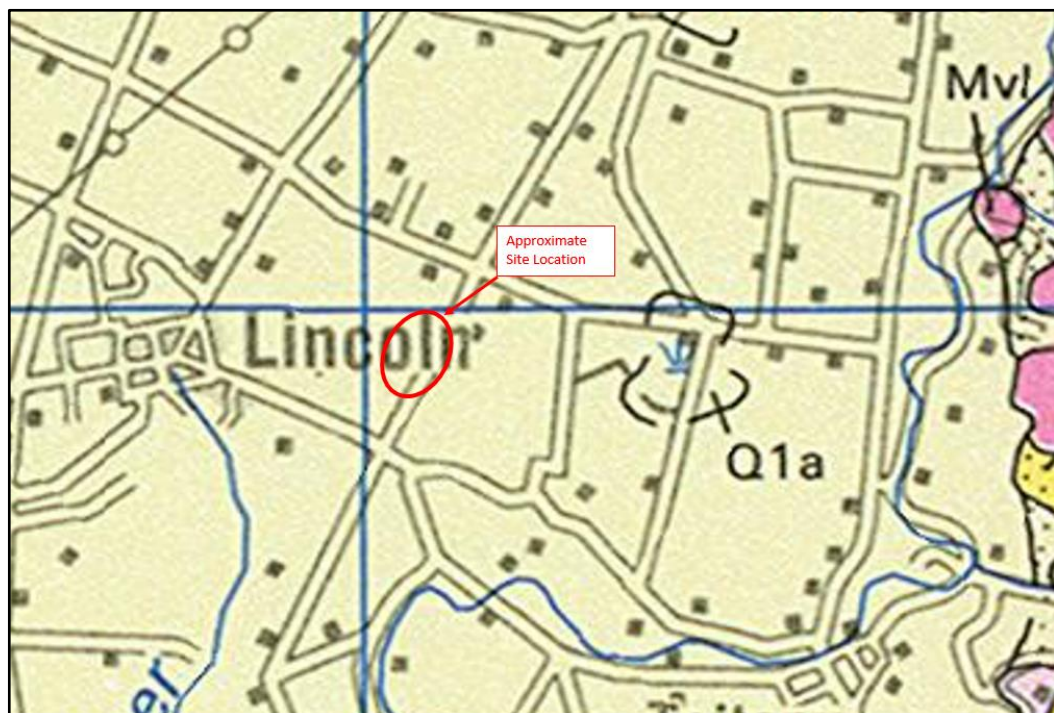
Figure 1: Geological map of site

The geology of the site is shown on the Geological and Nuclear Sciences Map 16, Geology of Christchurch area, scale 1:25,000 (compiled by Forsyth, Barrell and Jongens, 2008). The map indicates that the site is underlain by *grey river alluvium beneath plains of low-level terraces (Q1a)*.

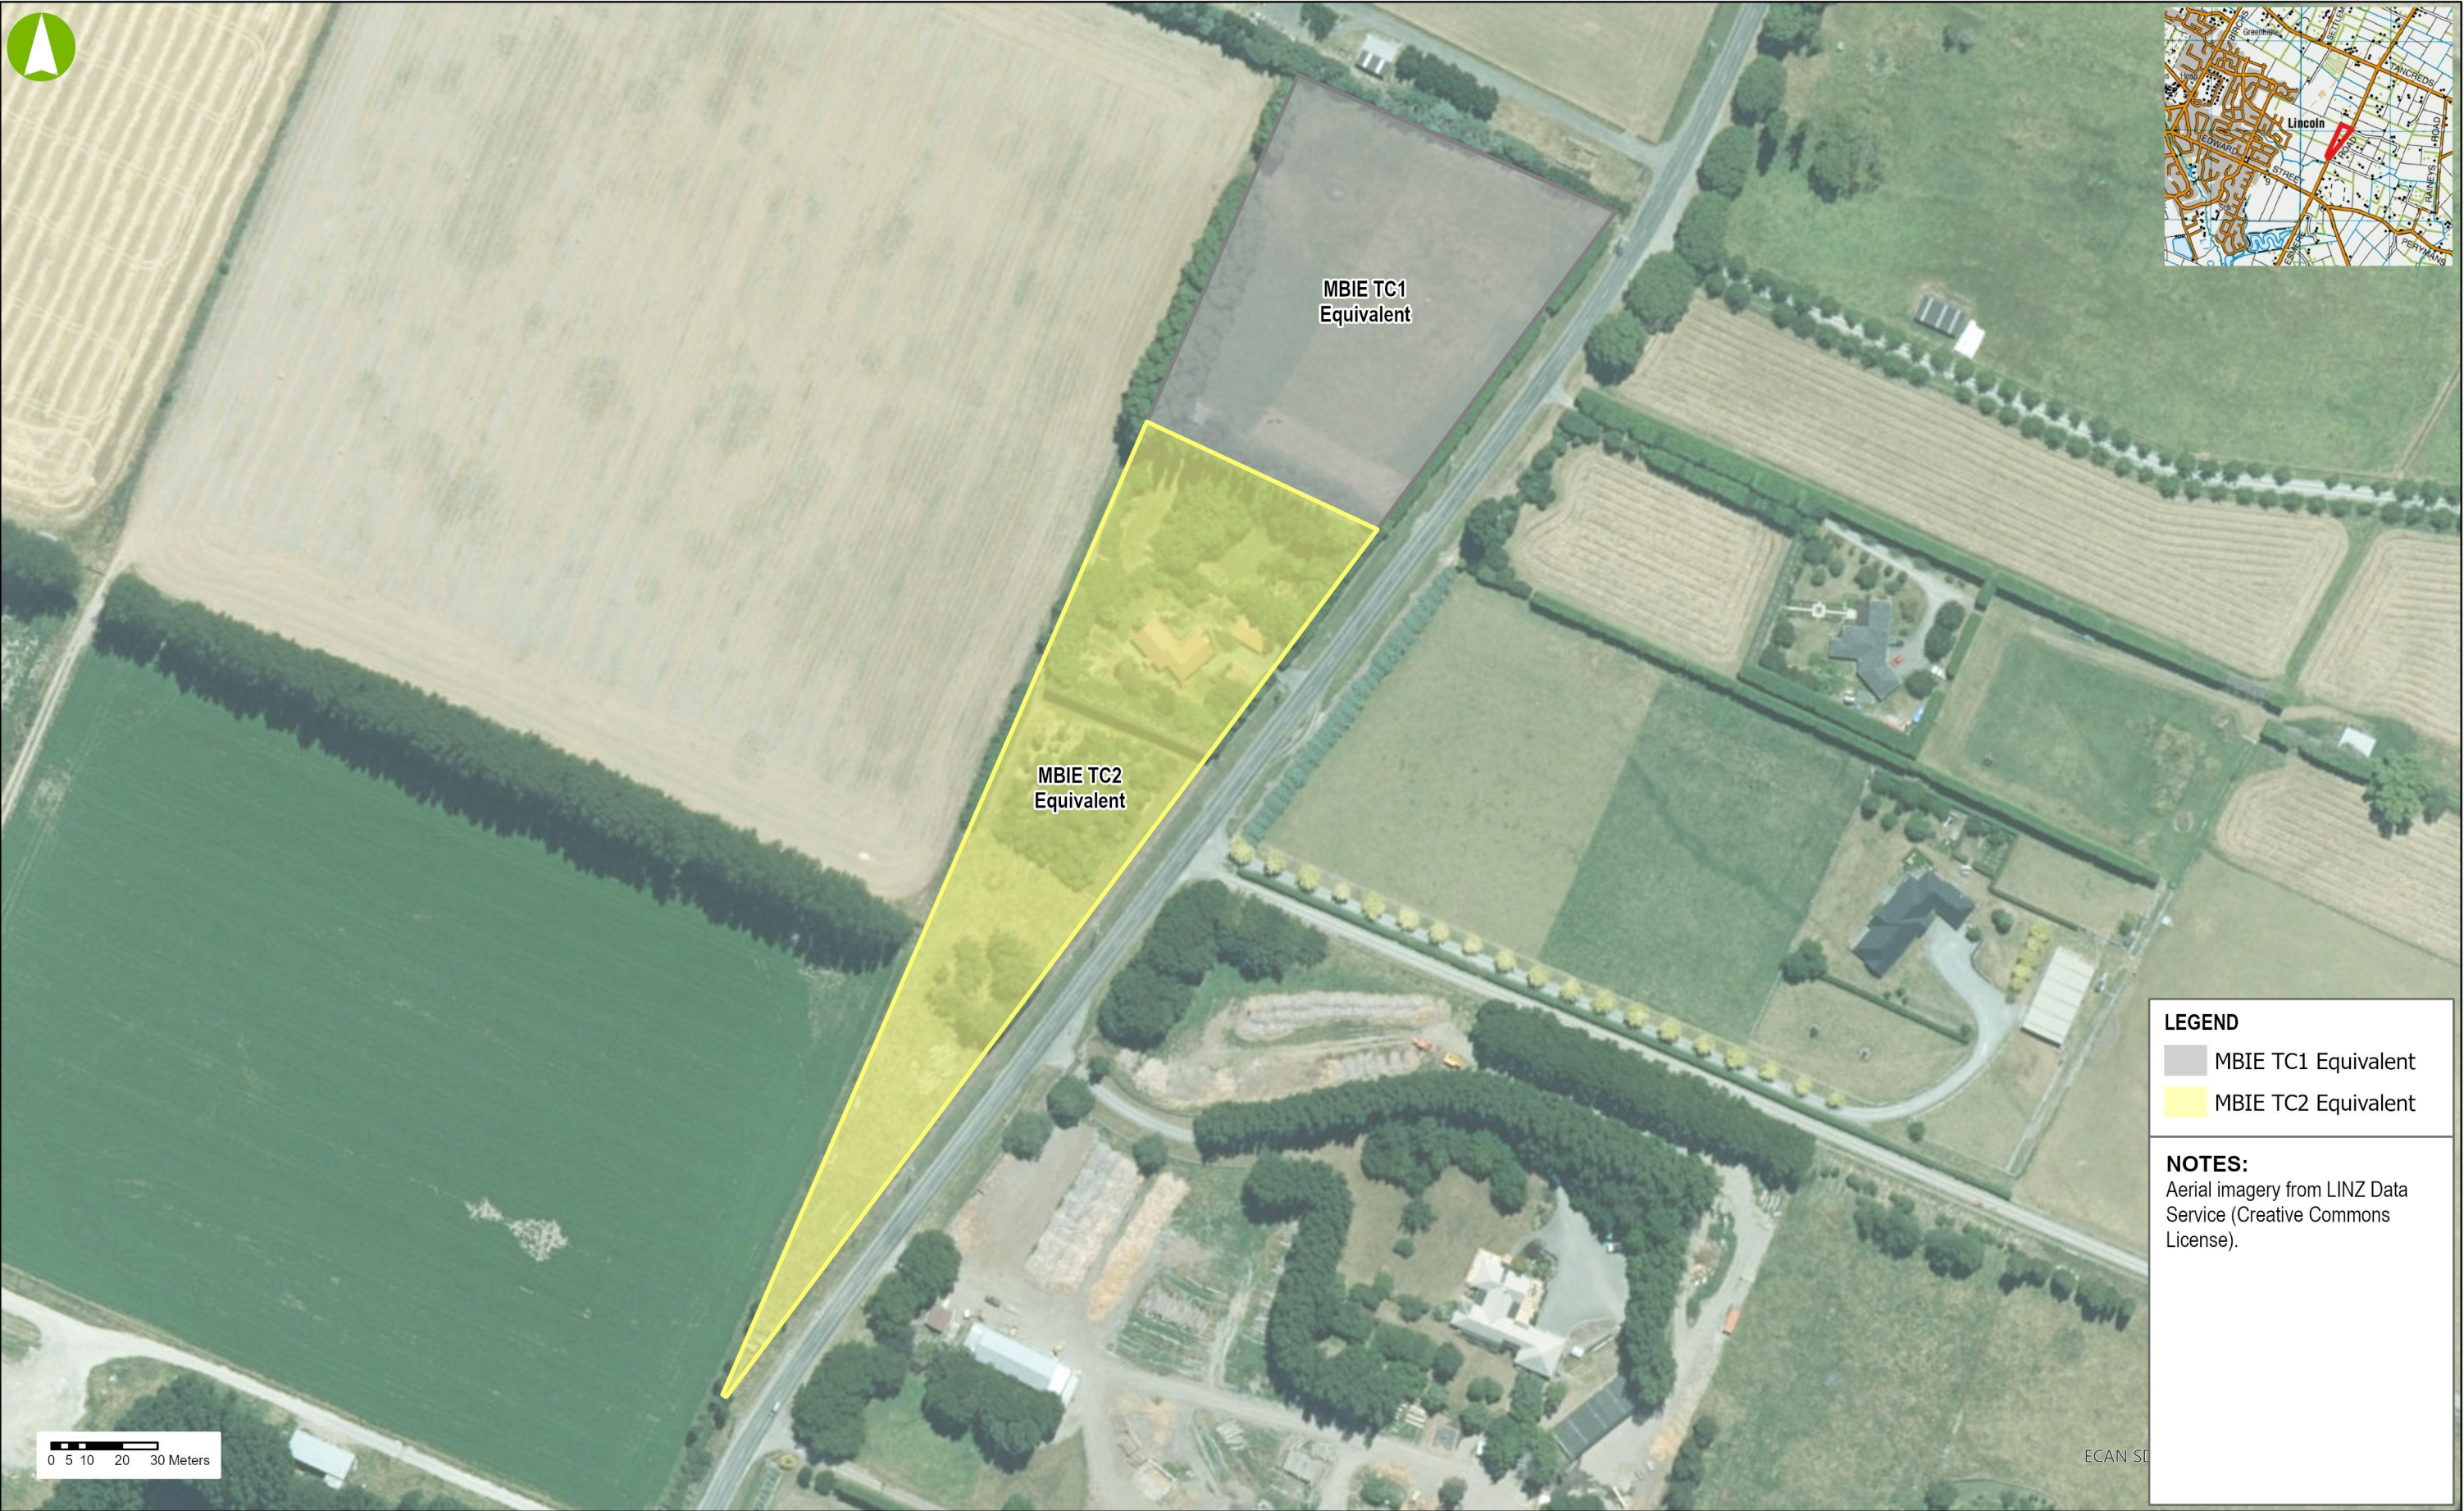
Based on our liquefaction assessment we consider that the northern part of Stage 25 is consistent with the classifications of **Technical Category 1 (TC1)** and the remainder of the site is consistent with the classification of **Technical Category 2 (TC2)**. Across Stage 25 future land damage from liquefaction is unlikely in the Technical Category 1 area, and possible in the Technical Category 2 area in future large earthquakes. The locations of the Technical Category zones are shown on see Figure 2 in Appendix A.

In summary, based off our liquefaction assessment, and observed ground damage we infer that minor to moderate land damage is possible in future large earthquakes. Areas of TC1 and TC2 classified land are shown in Figure 2 in Appendix A.
