## **Soil Contamination Risk Site Validation Report**

**642 Ellesmere Road, Lincoln**

February 2023

**Client:** Fulton Hogan Land Development Ltd

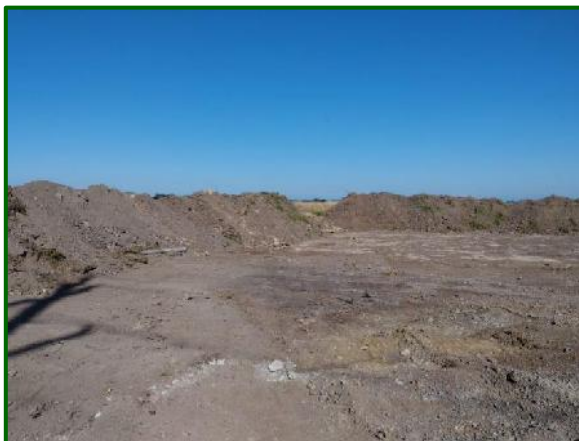
Photo 1 – Large stockpile requiring off-site disposal

Remediation of the site commenced in early January 2023. MEL attended site following the initial scrap to undertake XRF testing of the excavated area. The remediation area had been scraped to an average depth of 100-200mm with some pockets of deeper excavations where the contractor had identified small areas of rubbish. A large stockpile of soil was present in the centre of the site as the contractor had not been able to organise off-site disposal. XRF testing was completed across the excavated remediation area, except for beneath the stockpile which would be tested at a later date following off-site disposal. The XRF test results indicated large areas required further excavations due to concentrations of both arsenic and lead exceeding the ‘residential 10% produce’ soil guideline value (SGV). The contractor was advised to undertake further excavations across the majority of the remediation area and complete removal of the stockpile.

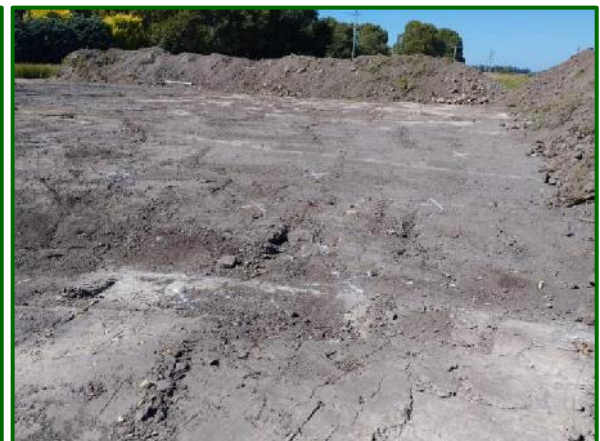
Photo 2 – Excavated remediation area

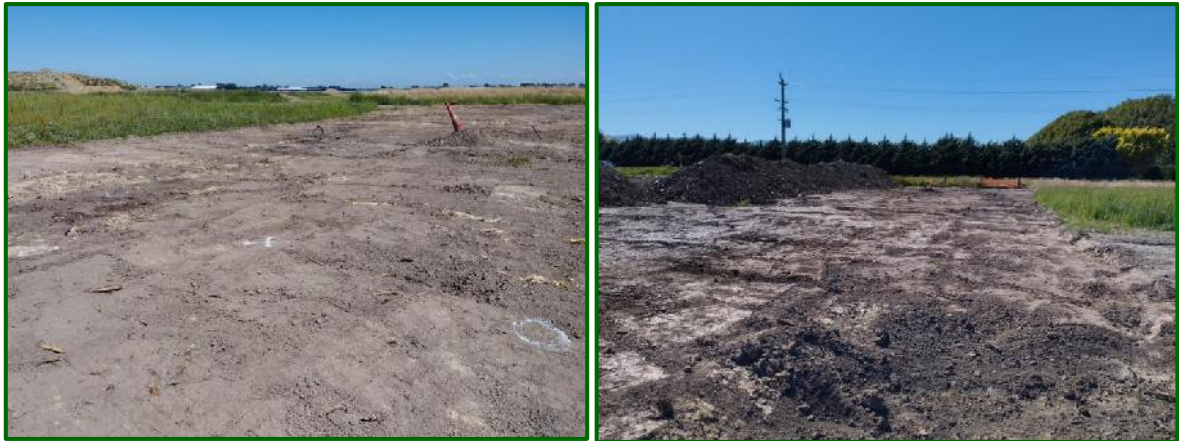
Photo 3 & 4 – Excavated remediation area

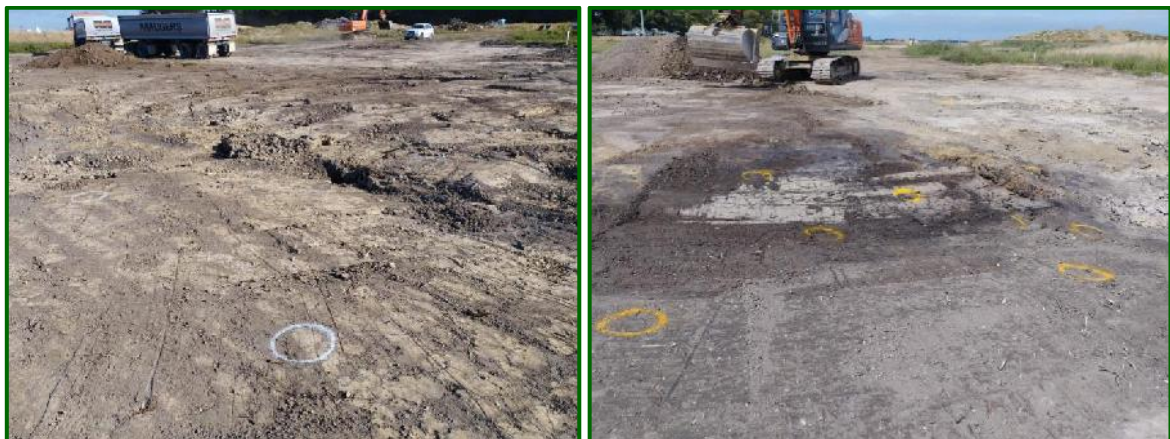
Photo 5 & 6 – Excavated remediation area

MEL attended site once the additional excavations had been completed, to undertake XRF testing of the excavated area. The large stockpile of soil had been successfully removed from the site and disposed of at Burwood Landfill. The XRF test results showed small pockets of soils with elevated concentrations of arsenic and lead remaining. These areas were excavated while MEL was in attendance and XRF tested to confirm successful removal. Overall, the remediation area was excavated to a depth of between 250-400mm.

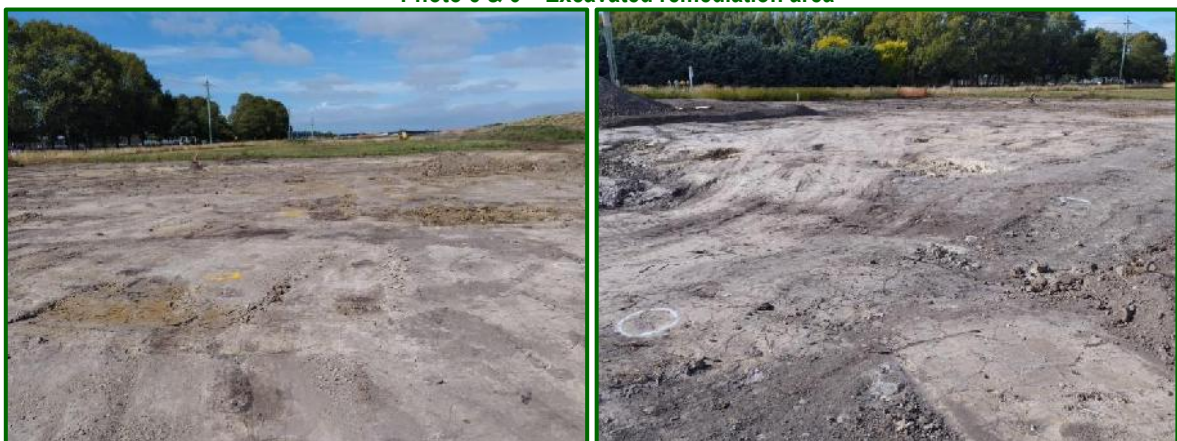
Photo 7 & 8 – Excavated remediation area

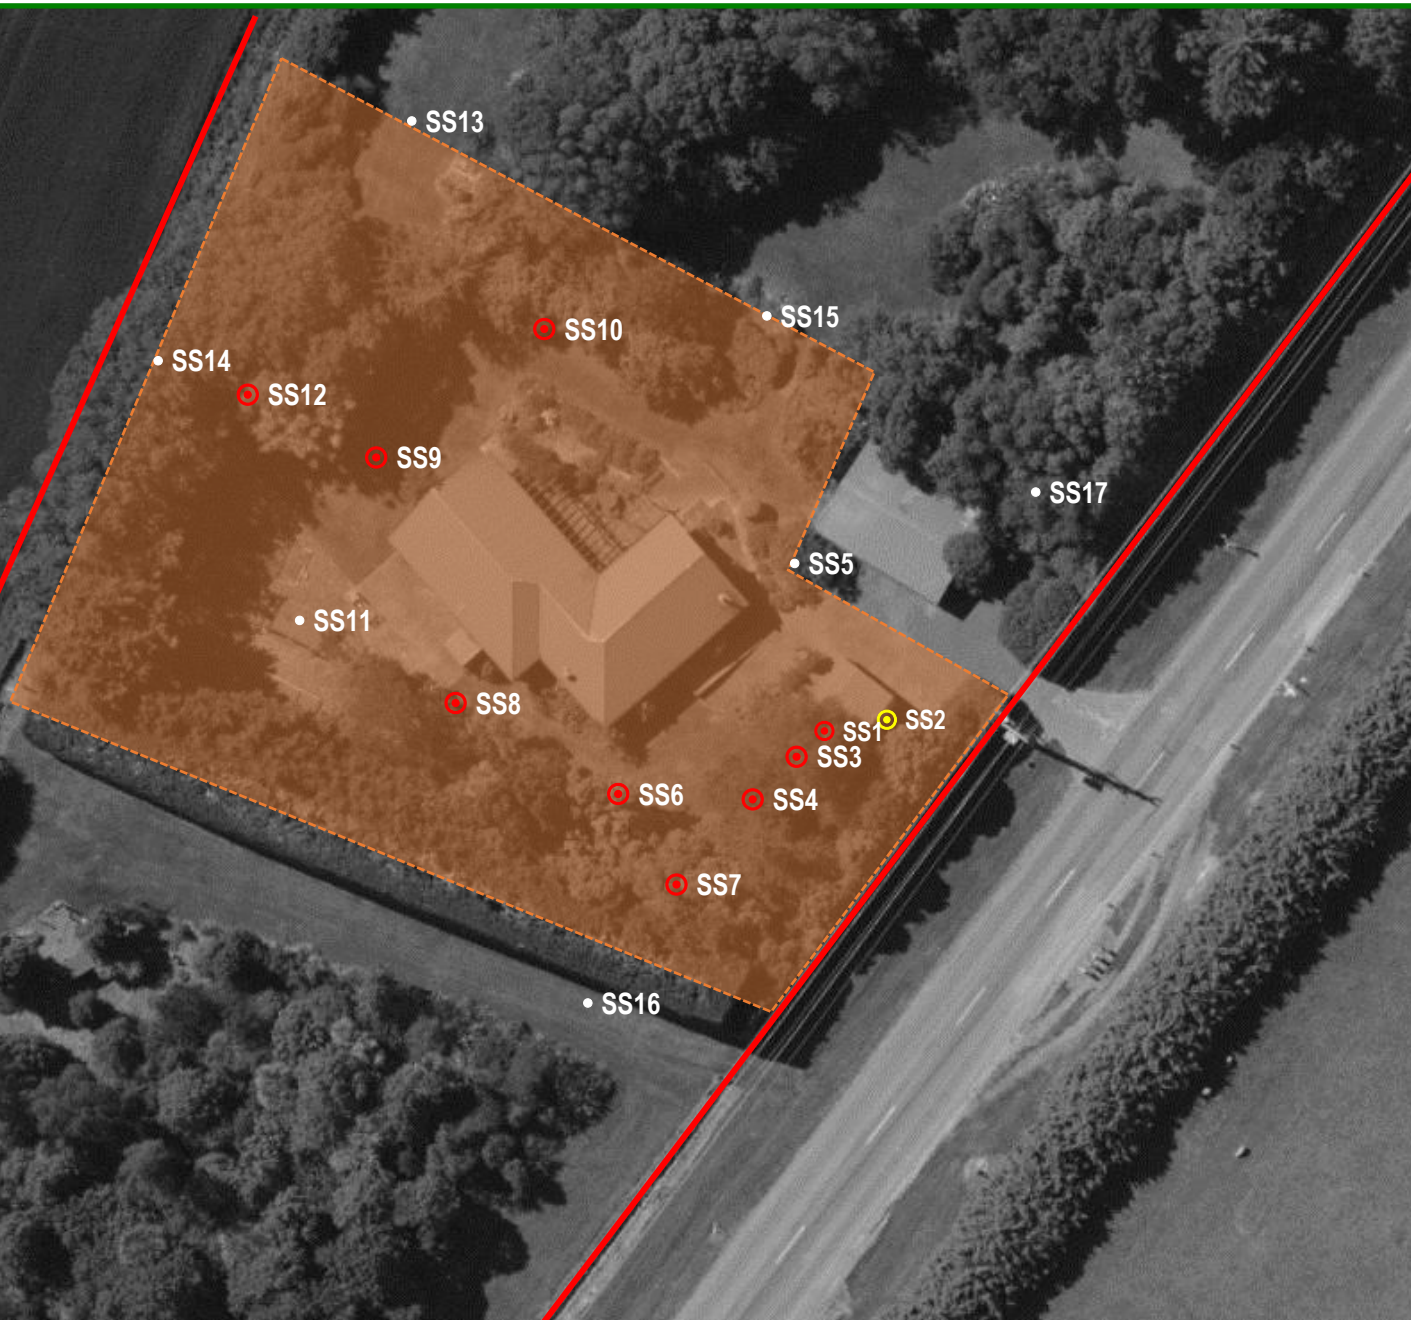
642 Ellesmere Road, Lincoln  
Sample Location and Remediation Plan

Based on the potential risks identified in the PSI, a DSI was undertaken by MEL in March 2022. Soil sampling was completed on 14 March 2022 and showed arsenic and/or lead contamination exceeding the 'residential 10% produce' soil guideline values (SGV) at eight sample locations surrounding the existing dwelling. The elevated concentrations appeared to extend to a minimum depth of 250mm. The maximum lead concentration recorded at the site was 851mg/kg compared to the 'residential 10% produce' SGV of 210mg/kg. The maximum arsenic concentration recorded at the site was 42.6mg/kg compared to the 'residential 10% produce' SGV of 20mg/kg. No asbestos was detected in the tested samples collected from the site.

- SS1 Soil testing location
- ⊙ SS1 Soil sample location exceeds residential SGV for lead
- ⊙ SS1 Soil sample exceed residential SGV for arsenic and lead
- ⬡ Proposed remediation area based on sampling to date – may be refined by further delineation when site is cleared

A copy of the Sample Location and Remediation Plan included in the DSI/RAP is attached in **Appendix B**.
